# TRUCKS, 1/4 TON AND 3/4 TON, LANDROVER, ALL TYPES

PANELS, FRONT WING LEFT AND RIGHT HAND

UNIT REPAIR

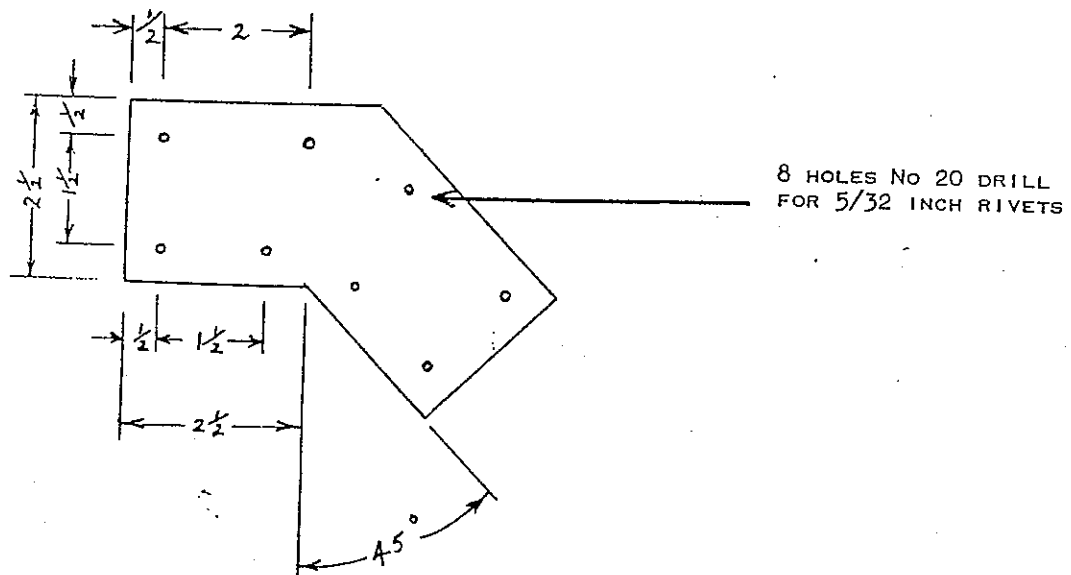
FIG 1 - REINFORCING PLATE

1. Cracking of the front mudguard rear well section has been noted.

2. When this occurs it will be repaired as follows:-
  - (a) Manufacture a support plate as shown in fig 1, using 12 SWG Aluminium Plate AS H48-75-H34 (AA-M578-1/2H).
  - (b) Drill 1/8 inch diameter hole at the end of the crack.
  - (c) Rivet the plate, on inside of wing panel at the corner where the cracking occurs, using 5/32 inch aluminium pop-type rivets.

NOTE:- Wing panels having cracks longer than 2 1/2 inch will require larger reinforcing plates.
